Research Paper INT-303

February 1983

Assessing and Monitoring Backcountry Trail Conditions

David N. Cole

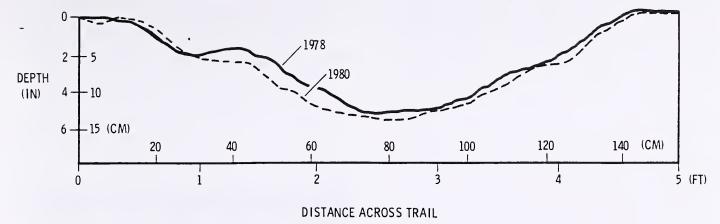
Results of the systematic sample of trail transects show that between 1978 and 1980, only 4 of the 10 sample sites experienced a net loss of soil; the cross-sectional area below the transect **decreased** on the other 6 sites, indicating that deposition of material exceeded erosion. On those sites with a net loss, the mean loss was 12 in² (77 cm²); losses ranged between 6 in² (39 cm²) and 17 in² (110 cm²). Generally more material was lost from lateral erosion of the "banks" of the trail than from further incision at the deepest part of the trail (fig. 3).

Figure 3.—The cross-sectional profiles for transect 8 indicate a net loss of 17 in² (110 cm²) of material (erosion) between 1978 and 1980.

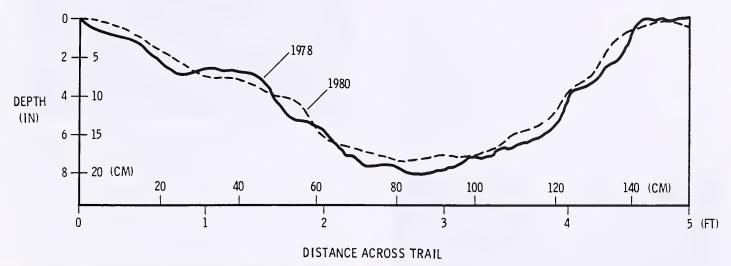
The mean decrease in cross-sectional area on those sites experiencing a decrease was 13 in² (84 cm²), with a range between 1 in² (6 cm²) and 47 in² (303 cm²). The decreases are a result of both slumping of the trail "banks" and infilling of the trail tread (fig. 4). The site where 47 in² of material was deposited had been disturbed by trail work immediately upslope.

Figure 4.—The cross-sectional profiles for transect 5 indicate a net gain of 15 in² (97 cm²) of material (deposition) between 1978 and 1980.

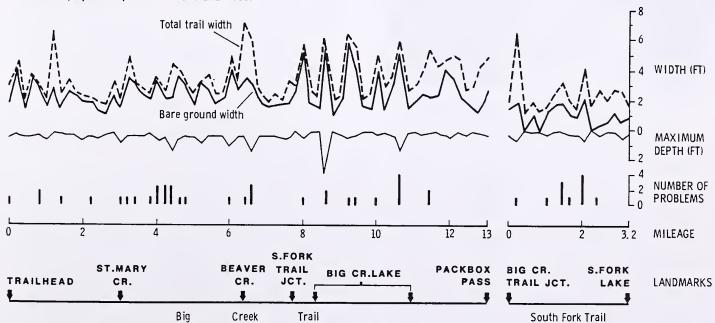
There are, however, certain trail segments with severe problems (fig. 5). Of the 83 segments, 13 percent were more than 5 ft (152 cm) wide; 1 segment was 7.1 ft (216 cm) wide. The width of exposed soil exceeded 4 ft (122 cm) in 8 percent of the cases, and reached 6 ft (183 cm) in one case. Of the segments, 35 percent had at least one problem and 12 percent had more than one problem. Three problems occurred on more than 10 percent of the segments: mud (17 percent); rocks (13 percent); and root exposure (11 percent). Incision of more than 10 inches (25 cm) occurred on 8 percent of the sites, and multiple trails were present at 5 percent. Lateral erosion and "washboard" were rarely encountered.

Figure 5.—Measurements and observations taken every 0.2 mile along the Big Creek and South Fork trails.
